# Notice to Mariners

## Rampion Offshore Wind Farm

Date of Issue: 10/02/2018

**Re: Rampion Offshore Wind Farm - Rampion Export cable surface laid & wet stored anchor cable.**

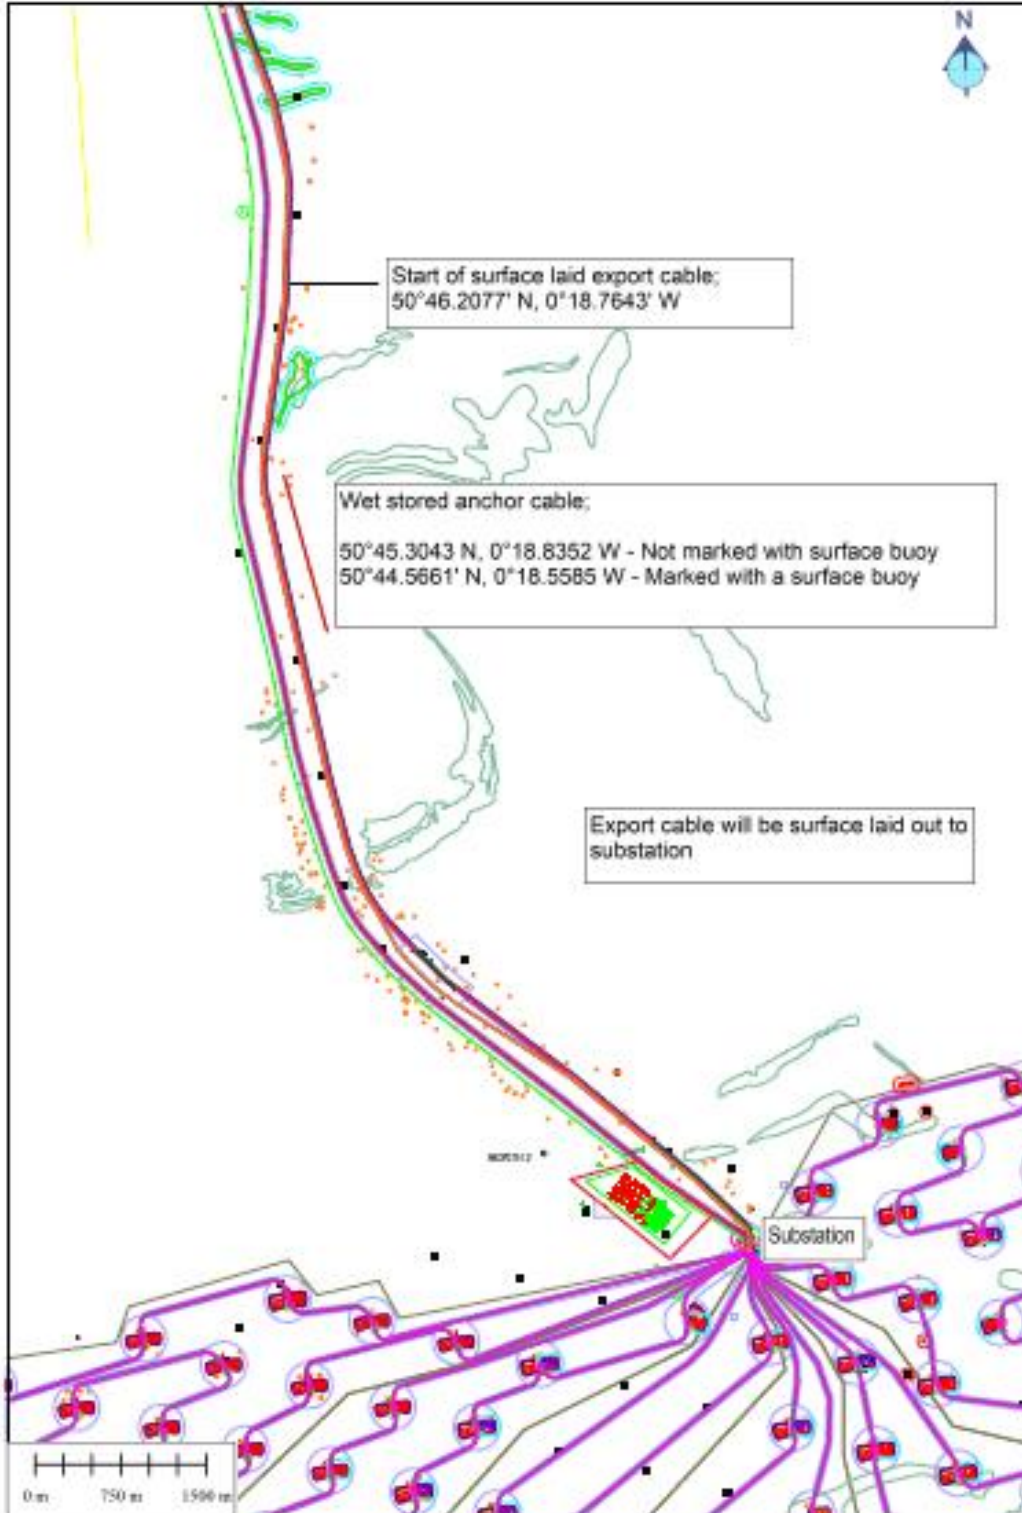
Due to technical problems and weather forecasts the Stemat Spirit will surface lay the export cable from KP5 to the Offshore Substation. Weather permitting there will be a guard vessel in the vicinity.

**Start of surface laid export cable;  
50°46.2077' N, 0°18.7643' W**

Due to technical problems with a winch there has been 1400 m of anchor wire laid on the sea bed. See chart below. Weather permitting there will be a guard vessel present until the wire is removed.

50°45.3043 N, 0°18.8352 W - Not marked with surface buoy  
50°44.5661' N, 0°18.5585 W - Marked with a surface buoy

**No such Gears, including anchors, come within the vicinity of the exposed/shallow buried cables.**

**Mobile or towed demersal fishing gears (trawls, shellfish dredgers etc) including anchors, DO NOT come within the vicinity of the cables**
